Grant Applicant: Washington Metropolitan Area Transit Authority (WMATA)
Proposed Project: Northern Bus Garage
Date: April 1, 2022

**INFORMATION REQUIRED FOR PROBABLE
CATEGORICAL EXCLUSION
(SECTION 771.118(d))**

WMATA plans to replace the existing Northern Bus Garage at 4615 14th Street, NW Washington, DC. Replacement of the existing bus garage is necessary as the existing facility has met its useful life and structural improvements are needed in order to maintain efficient storage/maintenance, replace deteriorating concrete conditions, better accommodate articulated buses, and reduce deadheading (non-revenue service). The existing facility is currently closed. The project is expected to begin in 2022 and be completed by 2026.

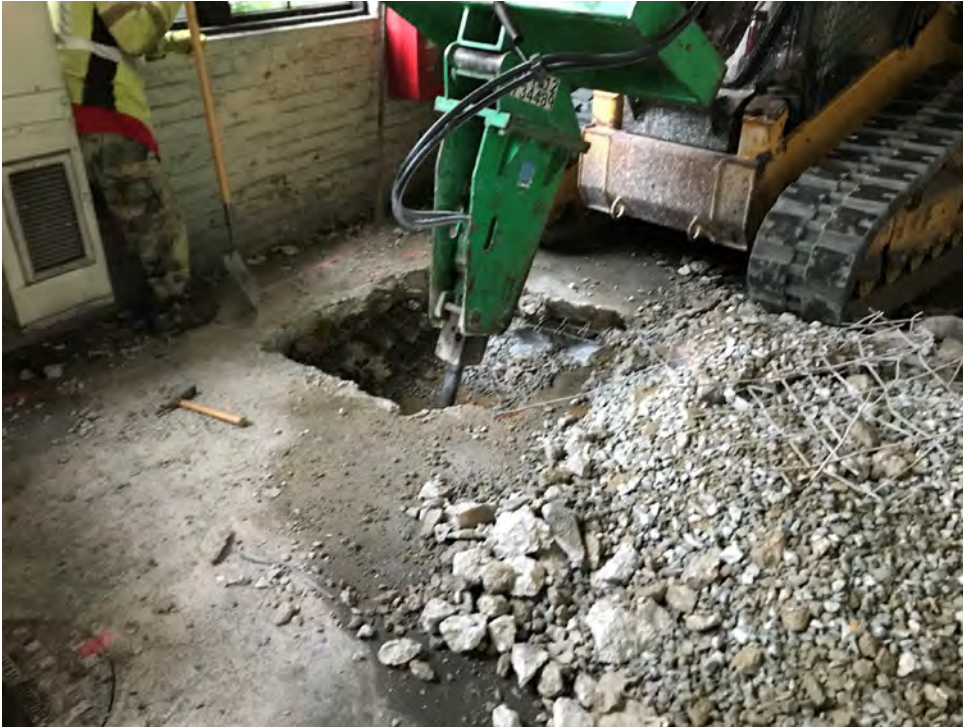
- Shown (left) is the progress of the first test pit searching for a wall footing
- The test pitting requires us to remove a small section of the concrete slab to access the soil underneath
- The soil is then mostly hand-dug, once accessible
- All soils will be backfilled into the pits once the foundation elements are surveyed

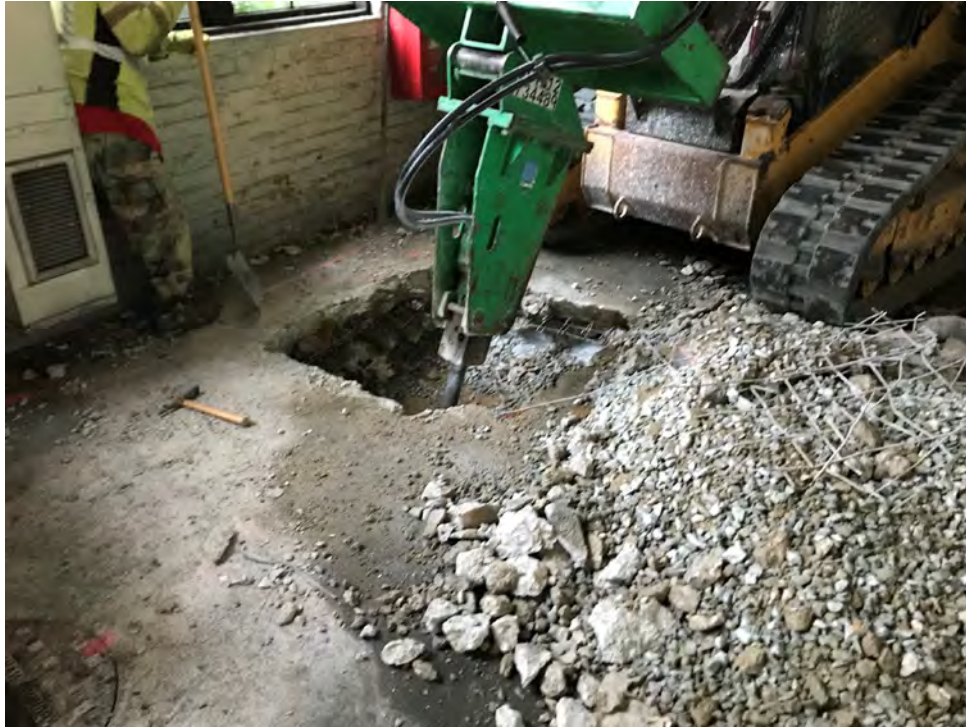
Field Progress Update

- Shown (left) is the progress of the first test pit searching for a wall footing
- The test pitting requires us to remove a small section of the concrete slab to access the soil underneath
- The soil is then mostly hand-dug, once accessible
- All soils will be backfilled into the pits once the foundation elements are surveyed

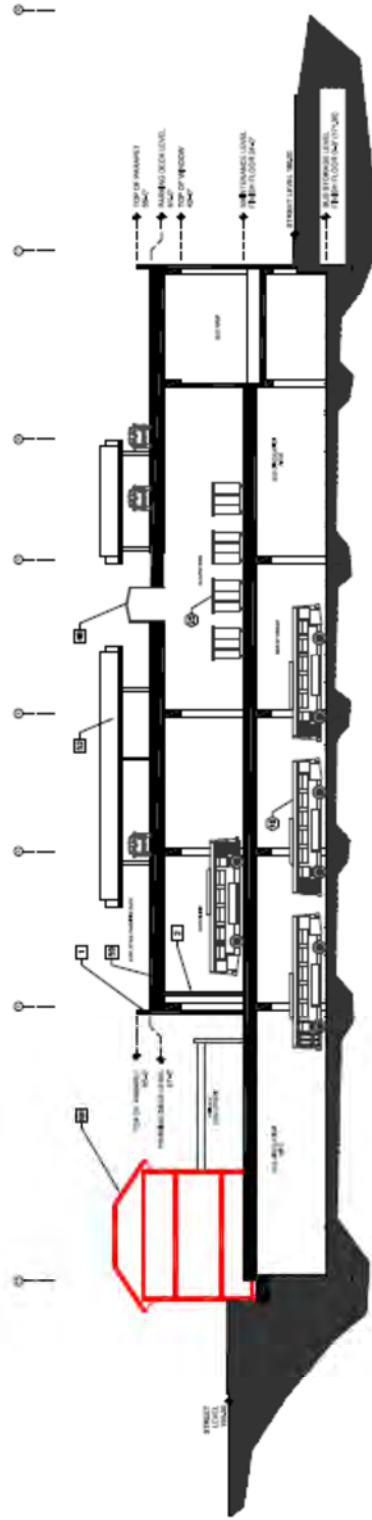
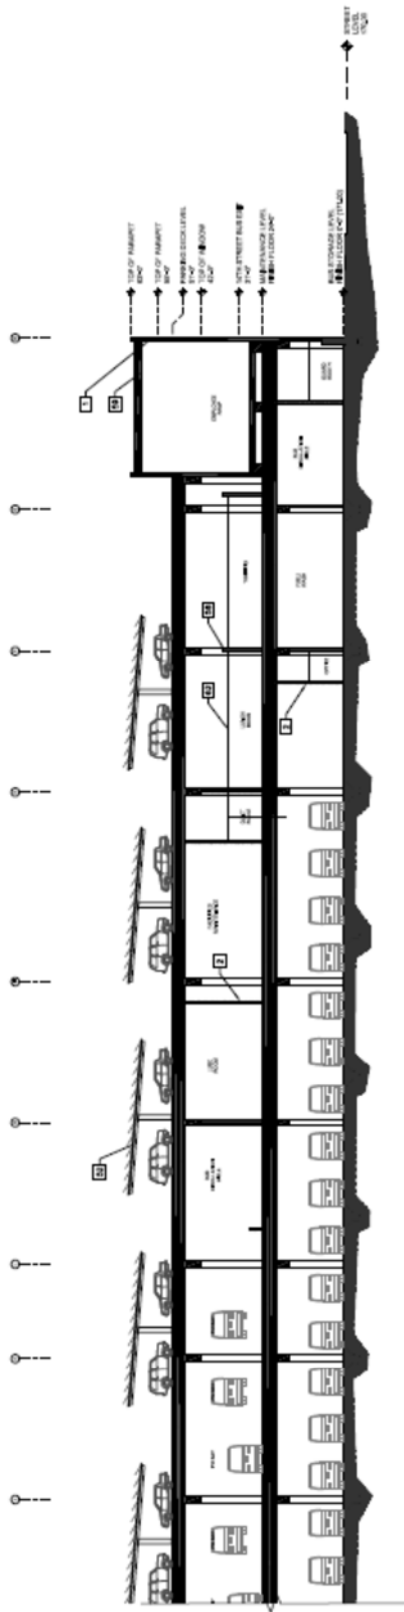
BUILDING SECTION 5 SCALE 1/8" = 1'-0"		1		0' 6" 12"		CONTRACT NO. F0282	
WASHINGTON METROPOLITAN TRANSIT AUTHORITY DEPARTMENT OF TRANSIT INFRASTRUCTURE AND ENGINEERING SERVICES OFFICE OF THE CHIEF ENGINEER, INFRASTRUCTURE		NORTHEN BUS GARAGE REPLACEMENT PROJECT BUILDING SECTIONS 3		1/18" = 1'-0"		SHEET NO. M220408	
DATE: _____ APPROVED: _____ CHECKED: _____ DESIGNED: _____ DRAWN: _____ DATE: 10/2/2018		REFERENCE DRAWINGS SECTION 5		DATE: 10/2/2018		DATE: _____ APPROVED: _____ CHECKED: _____ DESIGNED: _____ DRAWN: _____ DATE: 10/2/2018

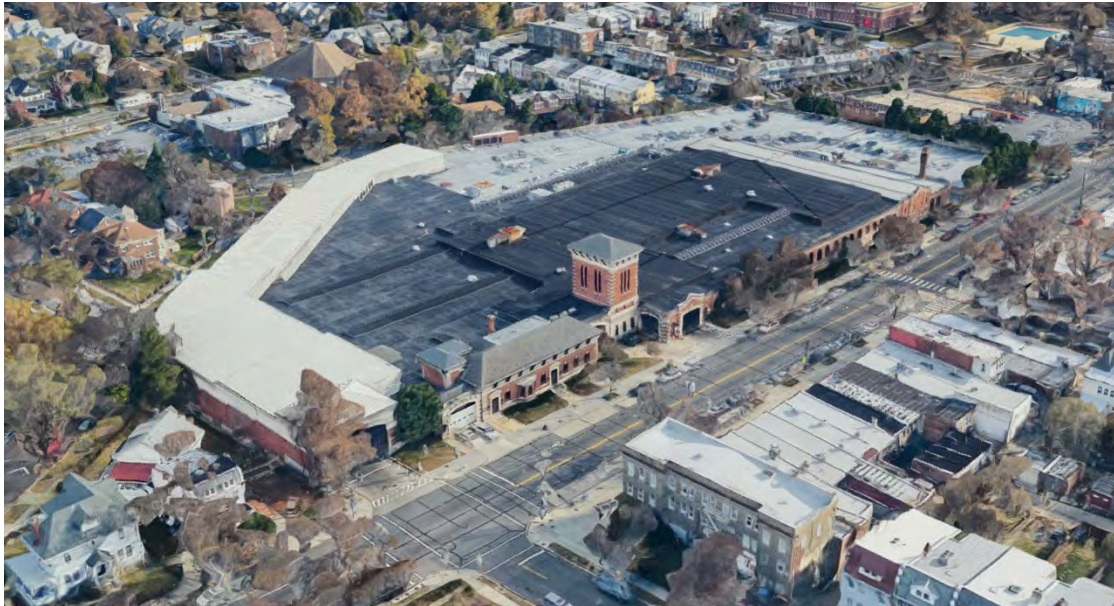
Figure 10. 1987 photograph looking east showing the extent of the demolition of ceiling and roof structure except for one bay along the perimeter of the east wall (WMATA Archive, George Washington University Special Collections)

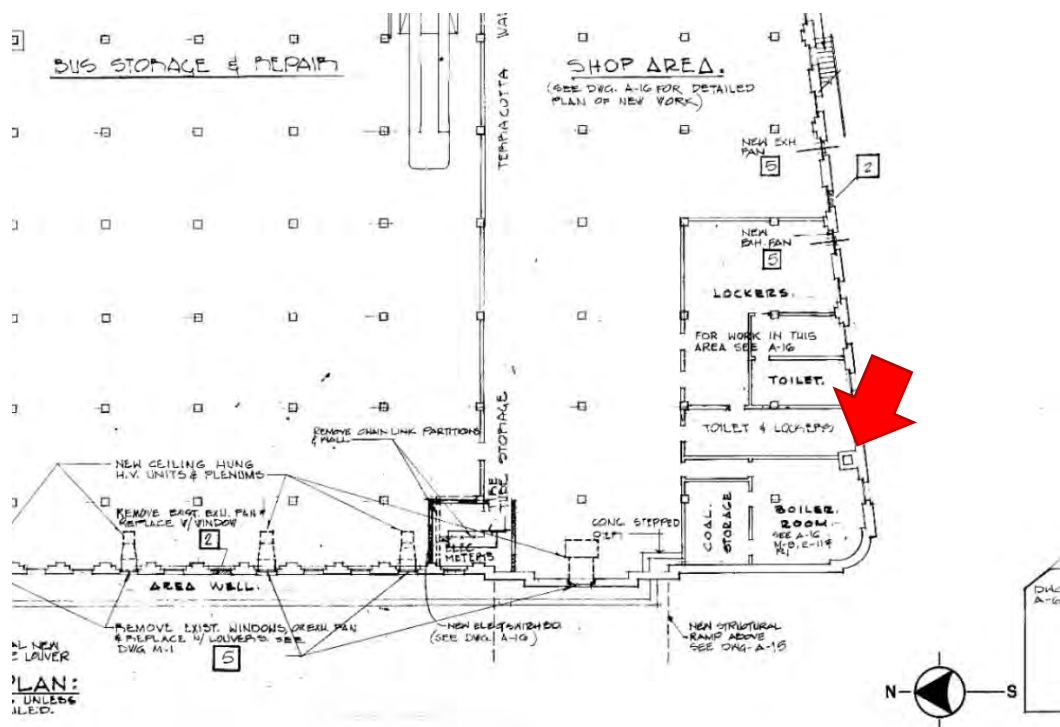
Figure 8. Angled brick wall on right constructed sometime after 1914 and prior to 1978. The wall created an additional interior room and enclosed the north elevation of the tower at that level. The other angled wall with the overhanging door was added after 1978 (BBB)

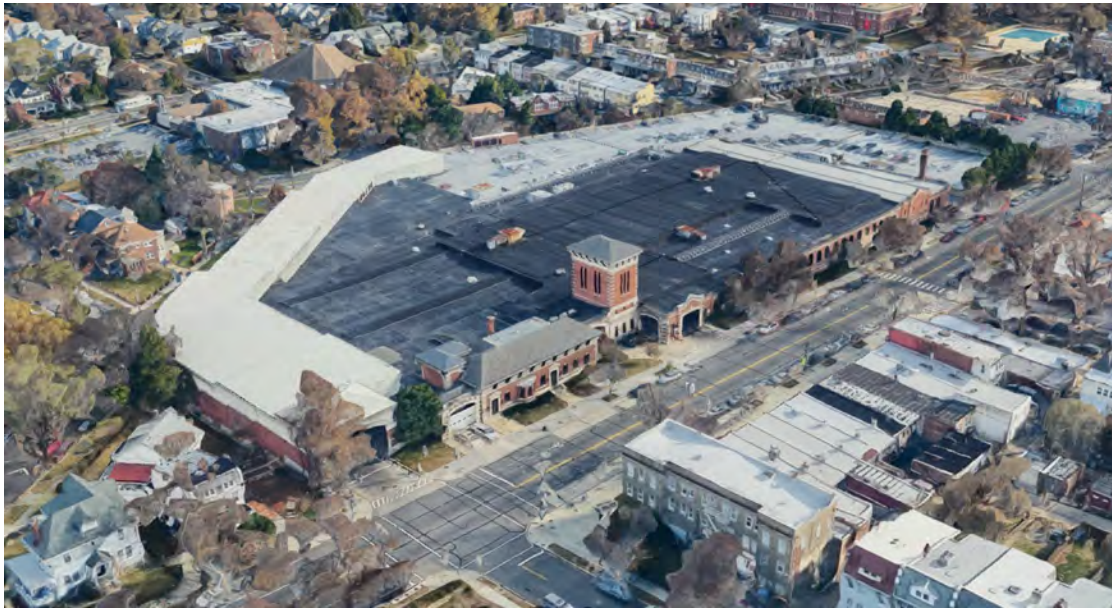
Figure 10. 1987 photograph looking east showing the extent of the demolition that occurred within the bus garage. The entire ceiling and roof structure in this area was removed except for one bay along the perimeter of the east wall (WMATA Archive, George Washington University Special Collections)

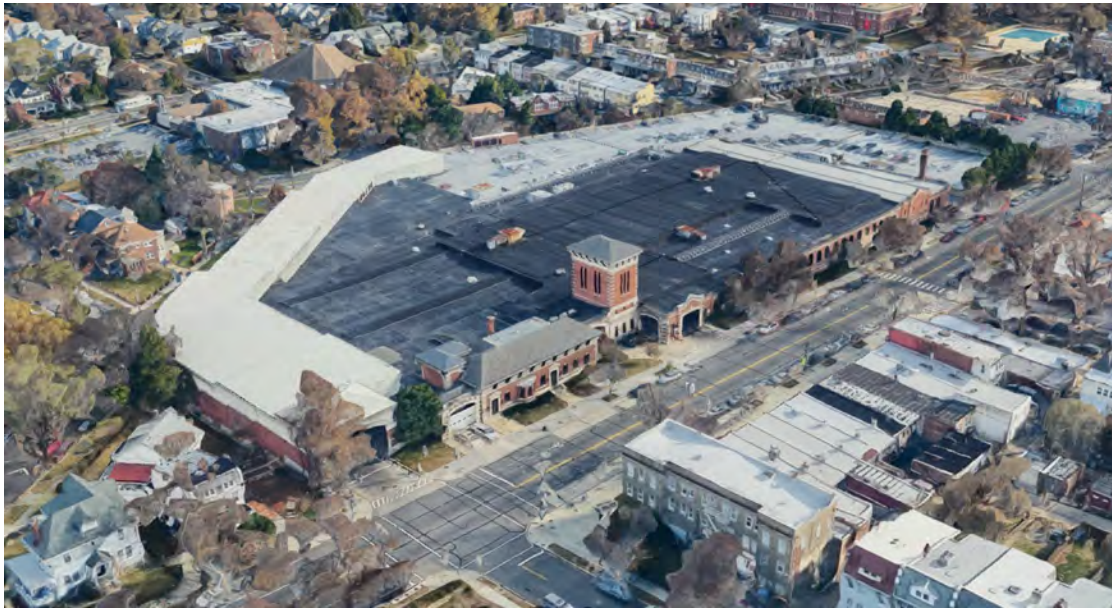
Figure 10. 1987 photograph looking east showing the extent of the demolition that occurred within the bus garage. The entire ceiling and roof structure in this area was removed except for one bay along the perimeter of the east wall (WMATA Archive, George Washington University Special Collections)

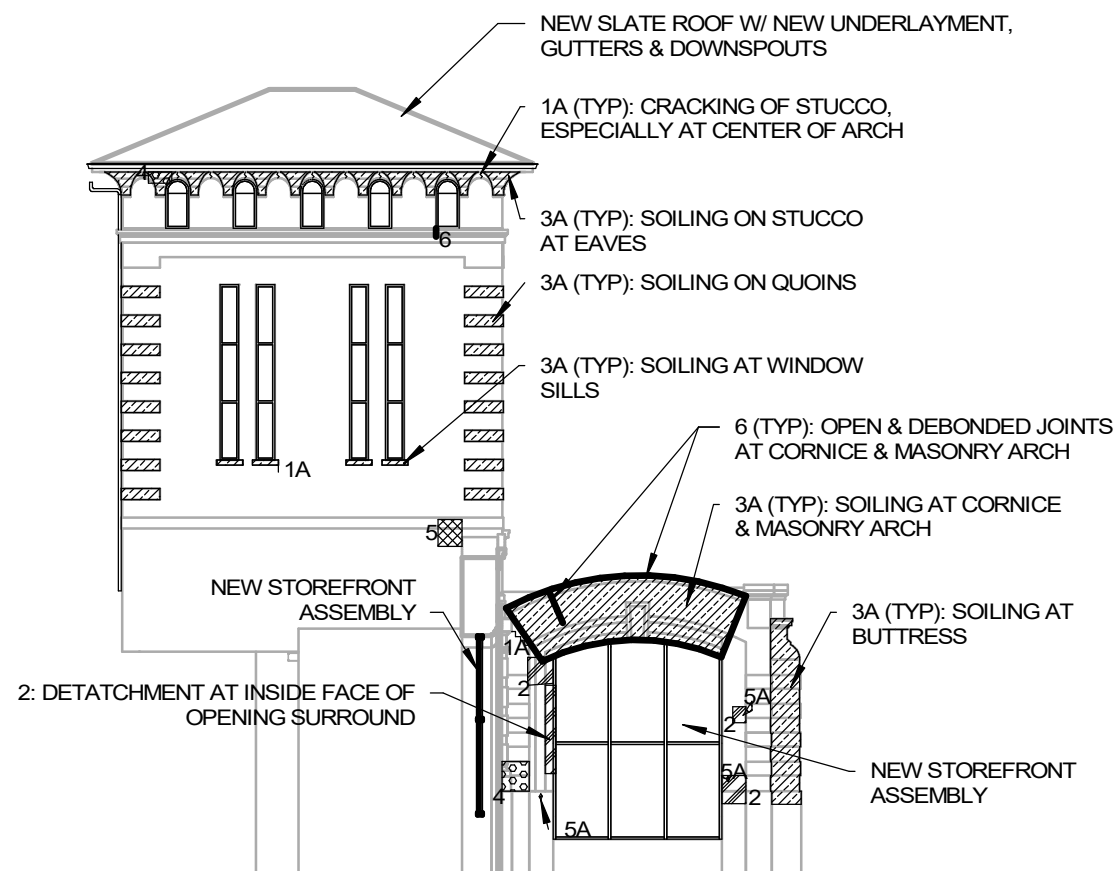
2
ER102
EL-04-02 TOWER NORTH ELEVATION - EXTERIOR RESTORATION
1/16" = 1'-0"
